JAHA
JOURNAL OF ANCIENT HISTORY
AND ARCHAEOLOGY

ANCIENT RESTORATION PRACTICES IN THE CITY OF PERGE

Adem YURTSEVER

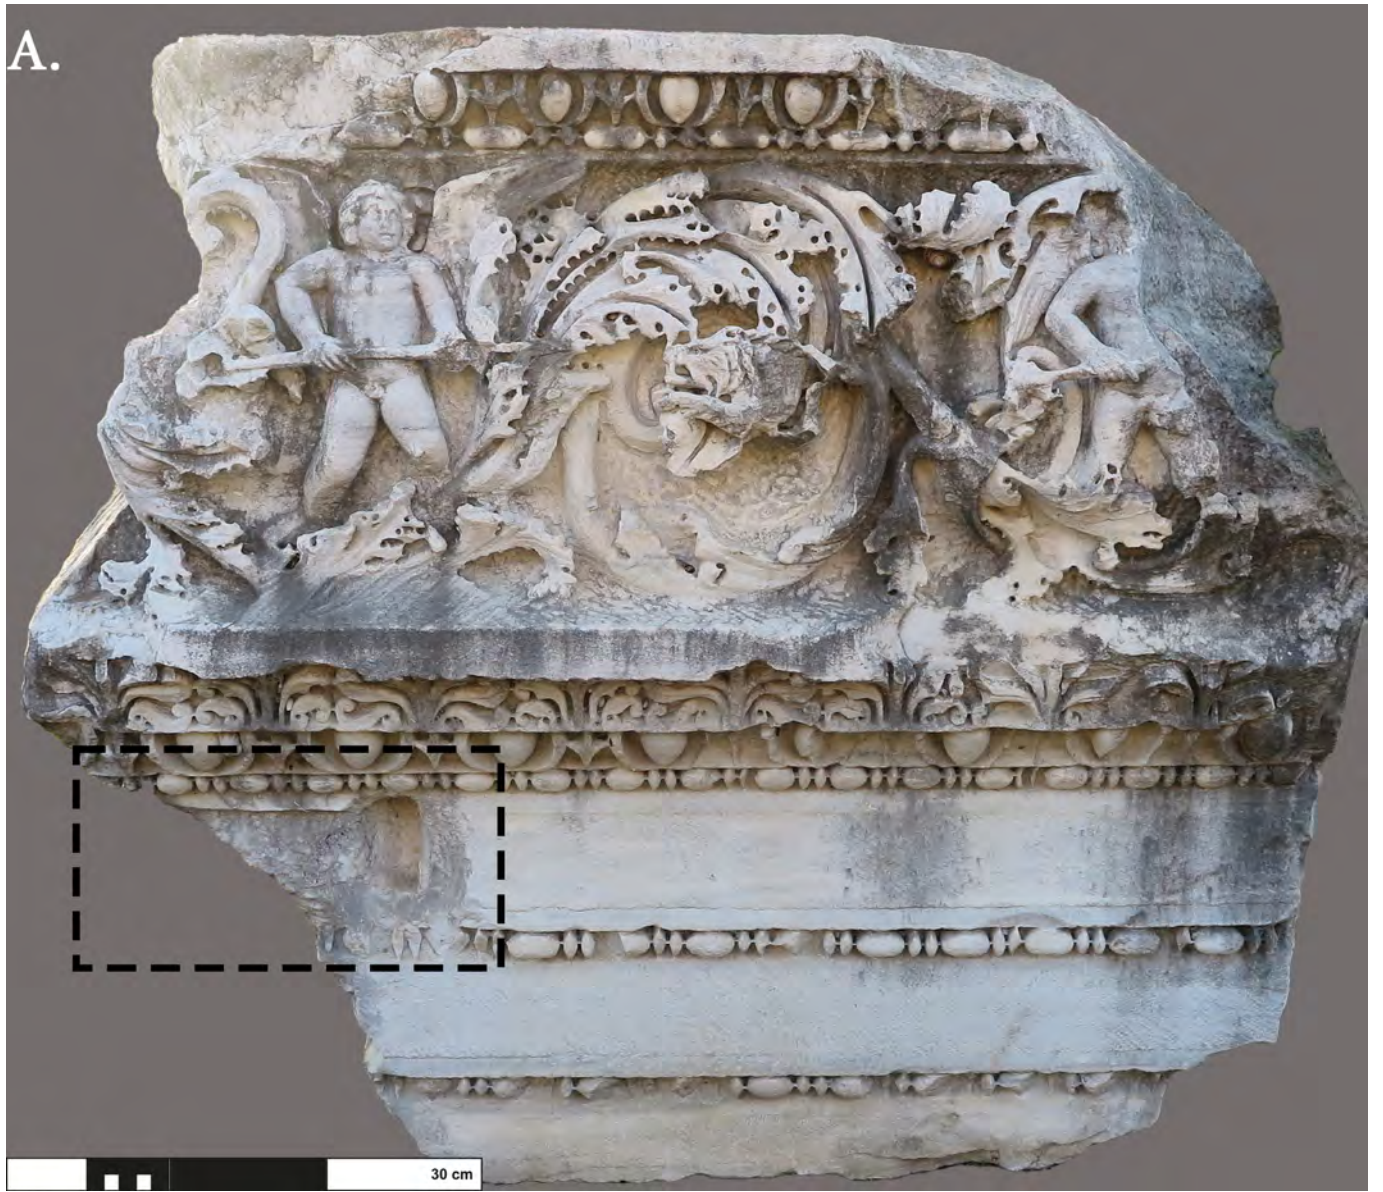
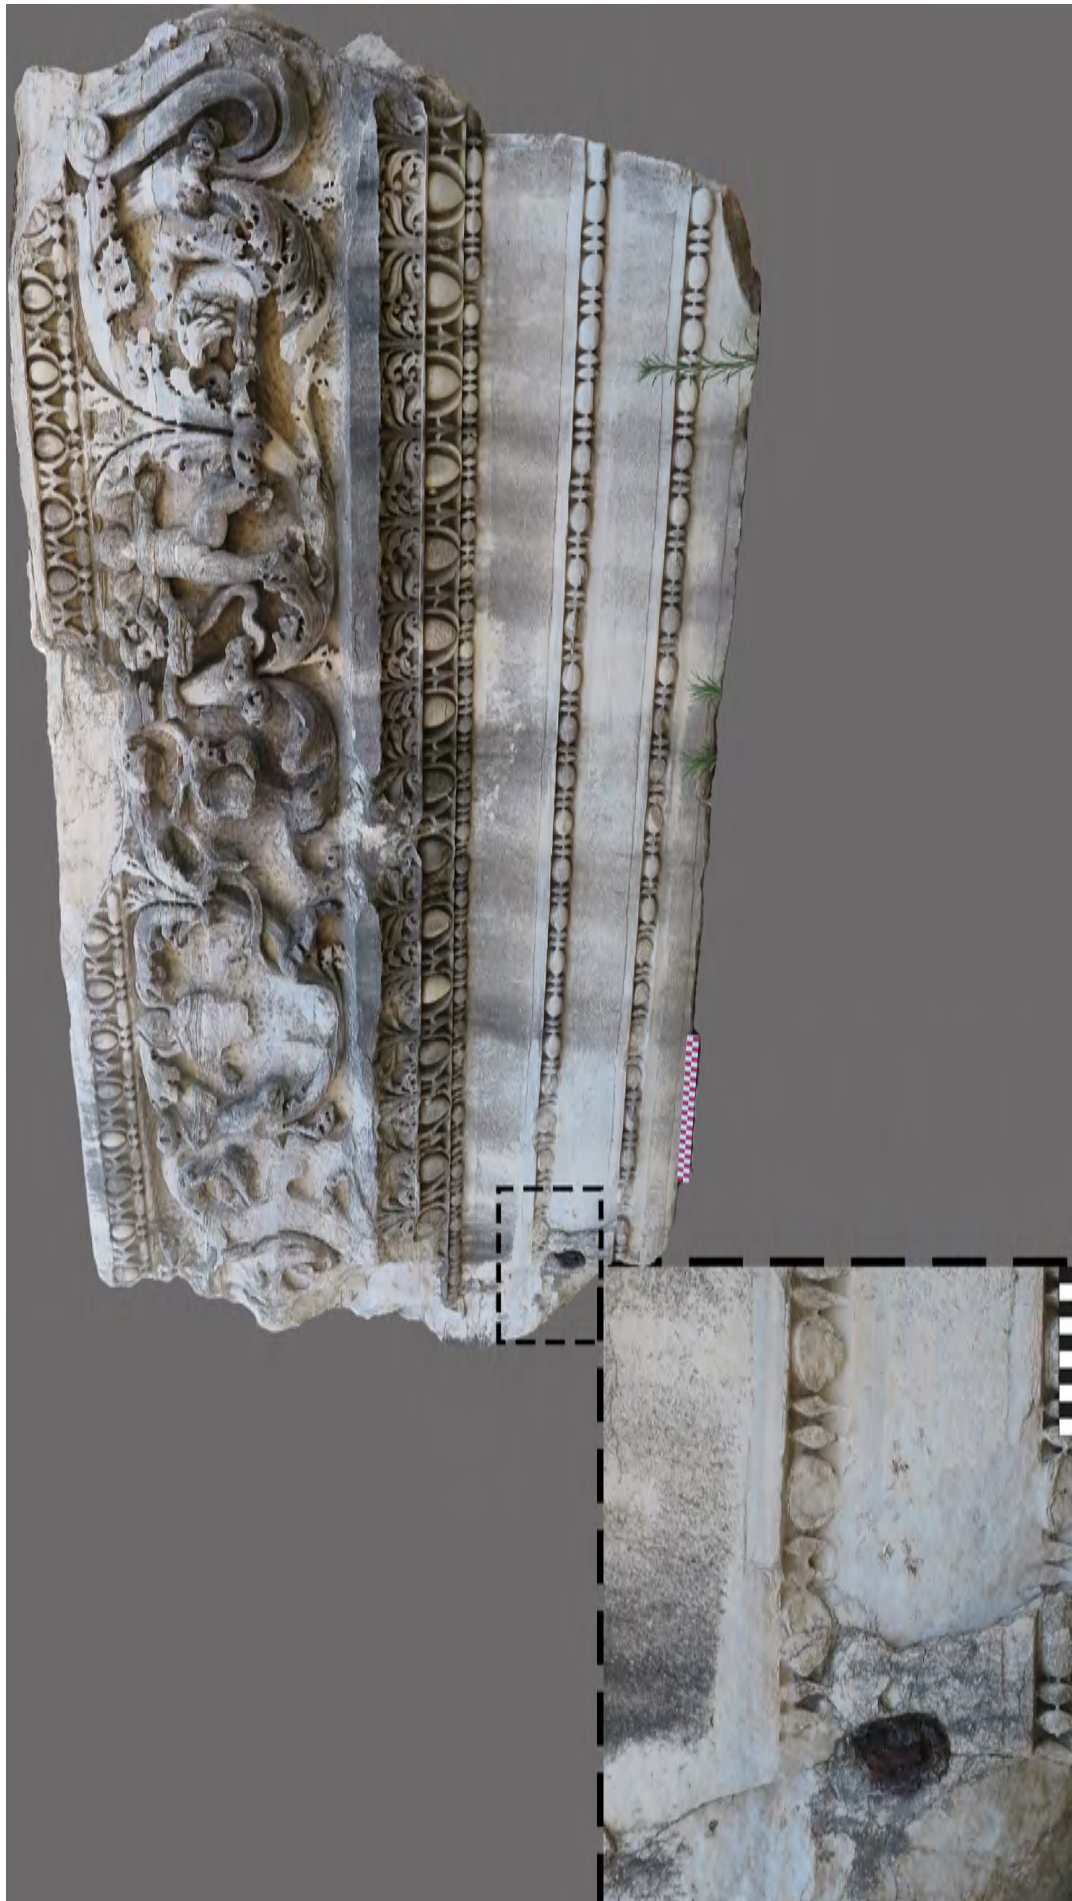
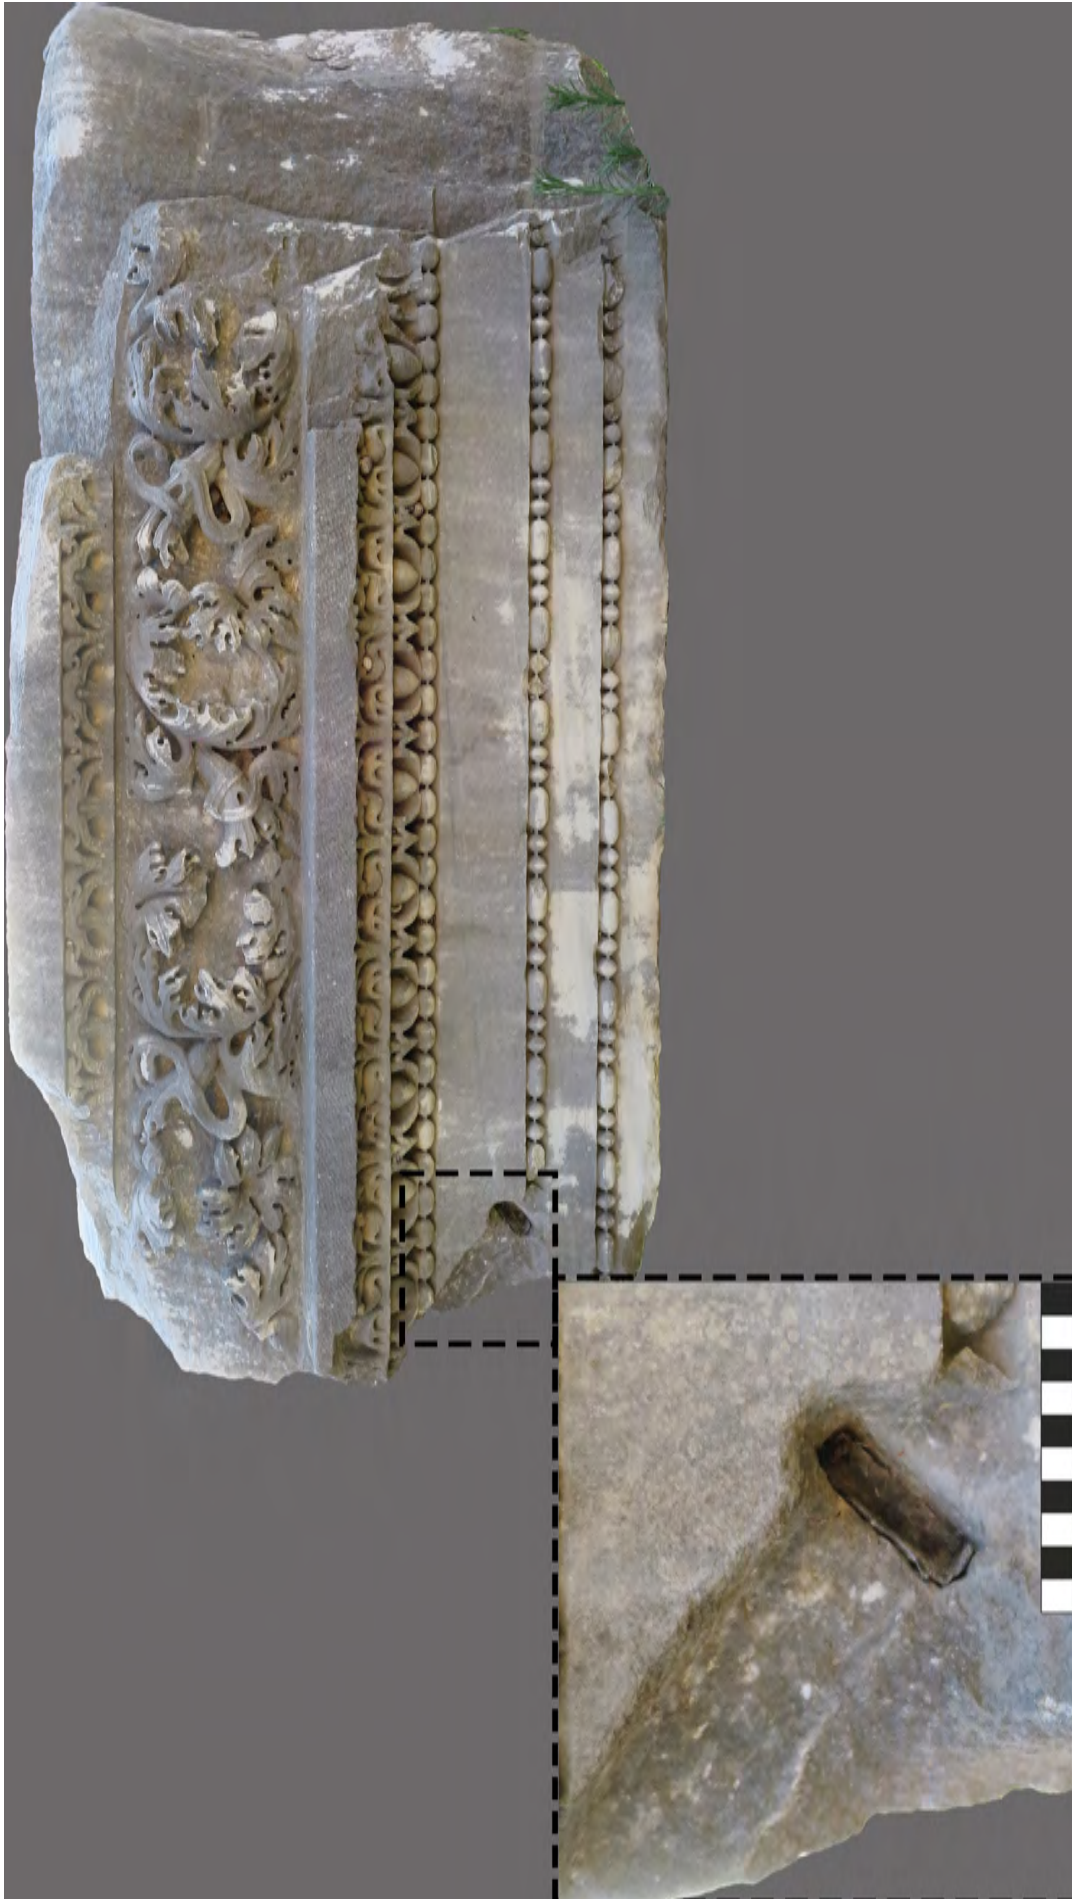
Fig. 3a. Ancient repairs on the structural elements of the Pergé theater.

Fig. 3b. Ancient repairs on the structural elements of the Pergé theater.

Fig. 3c. Ancient repairs on the structural elements of the Pergé theater.

Fig. 3d. Ancient repairs on the structural elements of the Pergé theater.

Fig. 3e. Ancient repairs on the structural elements of the Pergé theater.

of the Perge examples, the A-2 restoration practice, which is a subvariant of the Type A restoration practice according to Ismaelli's classification, is evident¹⁴. Looking at the architrave surface, it is understood that the metal clamps placed horizontally or diagonally extend over the fascia and bring the two blocks together. In some examples, the metal traces of the clamps on the block are still visible. However, it is understood that some decorated elements on the block were also destroyed during repair. The destruction of the decorated elements was not a problem here; the priority was to reuse the block (Fig. 3a-e).

Some of these applications at Perge were introduced by A. Öztürk and N. Atik¹⁵, while Ismaelli discussed the techniques of these works¹⁶. The newly discovered blocks did not differ from the previous blocks. There are several important points that drew our attention from Öztürk's study. Öztürk found that renovations were carried out in the lower stage building of the theatre, and in some cases, different types of stones were used in the plaster capitals instead of Prokonnesos marble¹⁷. He also briefly mentioned the repairs on some architraves. He stated that these repairs may have been made as a result of a mild earthquake¹⁸.

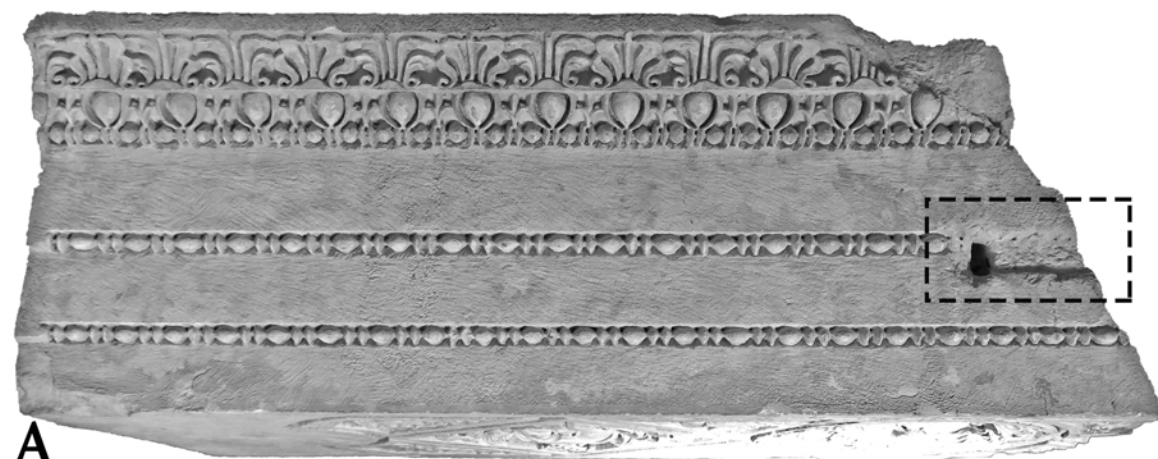
Fig. 4a-c. Antique repairs on structural elements of the propylon of the South Hammam-Gymnasium at Perge.

There are similar examples of this practice found in the theater of Perge and in other buildings in the city. A similar practice was documented on the façade of the architrave block of the propylon¹⁹ of the city's bath gymnasium (193–211 AD)²⁰. On the front façade of the architrave, currently on display at the Antalya Archaeological Museum, traces of a "II" shaped clamping iron can be seen on the spool-bead decorated crown of the horizontally shaped second fascia (Fig. 4a). It appears that the architrave, which was broken into two pieces for some reason, was reassembled and used owing to this application²¹. Moreover, traces of the same technique were found on different architraves lying on the ground around the area where the propylon was found (Fig. 4b-c). The reason for the restoration of the architrave of the propylon at Perge is unknown²². However, such a practice indicates that the blocks were damaged after a severe earthquake and that the broken blocks were repaired and reused²³. Apart from the example of propylon, a similar restoration

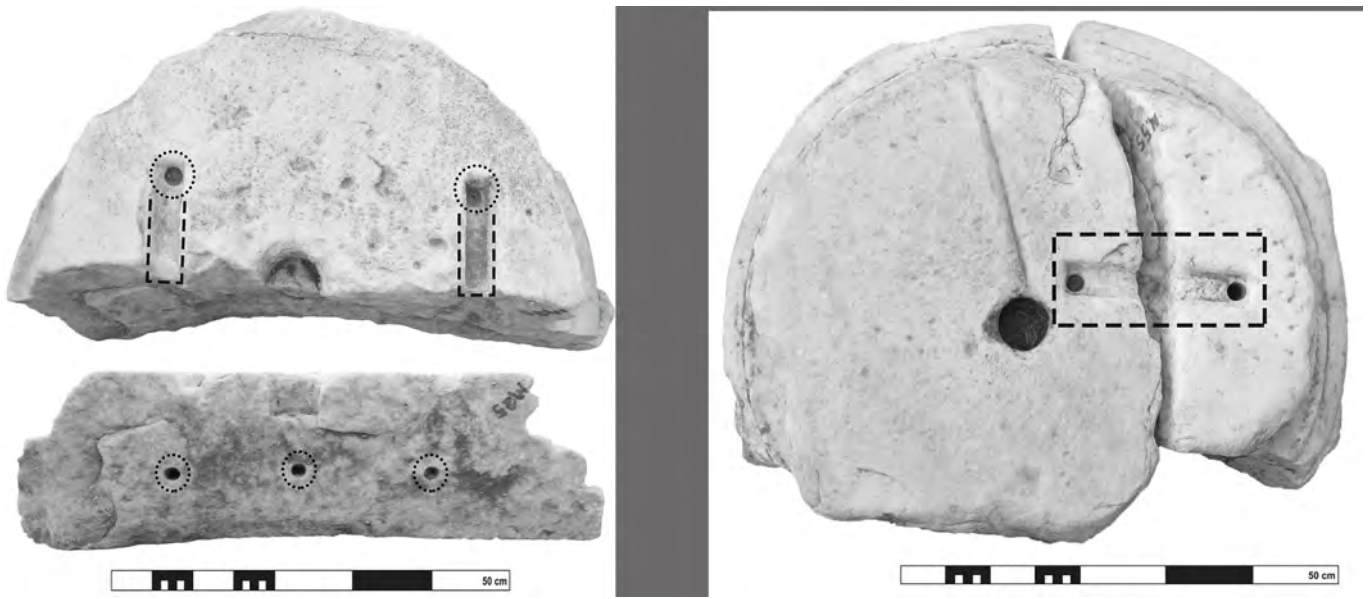
Fig. 8. Repairs detected on attic-ion type pedestals belonging to the emperor's hall of the gymnasimun in Side (after YURTSEVER 2021a, Pl. 11,3; 27,2).

The building elements evaluated in the Type A class and their comparison examples are mostly large-scale building elements such as architraves. However, some attic-ionic type pedestals from the gymnasium of the ancient city of Side show that the application was also carried out on relatively smaller blocks. Traces of dowel and metal clamp slots on the attic-ionic type pedestals here, which indicate ancient restoration, have been documented³⁹. Slots were formed on the bodies of the column bases, which were broken in two, and clamps were placed on the upper base surface. Thus, the pedestal, which was split in two, was brought together and reused in the restoration. It is quite clear that this practice indicates a building phase. The interventions made at different points to split the pedestals in the middle and reuse them indicate a comprehensive restoration. Research on the building also indicates that the building underwent restoration in the late 2nd to early 3rd century AD⁴⁰. It is understood that the column bases were also repaired during this restoration (Fig. 8).

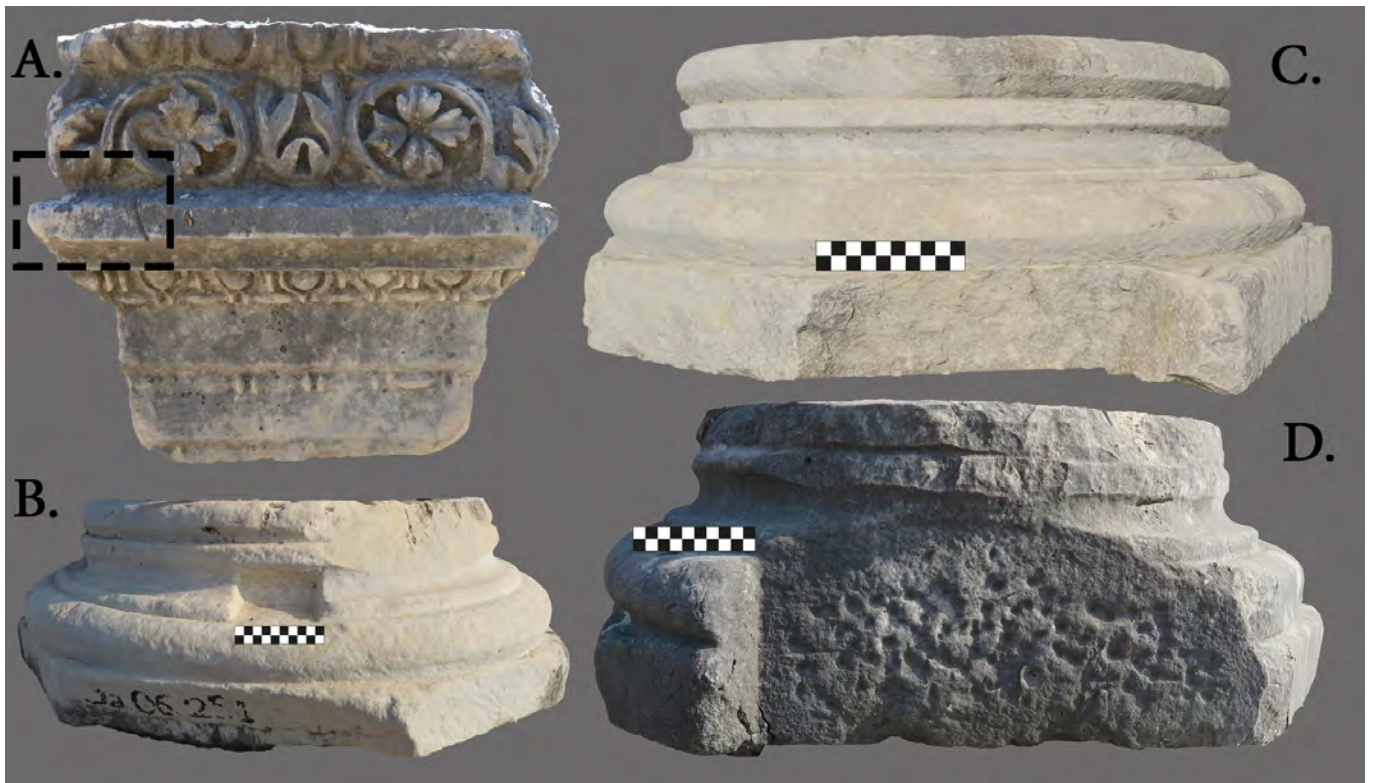
Fig. 9a-e. Examples of Type C repairs at Perge. **A:** Architrave of the palaestra of the South Bath-Gymnasium. **B-D:** Repairs on the attic-ion type pedestals on the colonnaded street running north-south.

During the surveys conducted at Perge, clear examples of this ancient restoration practice, classified as Type C, were found. One of these examples was documented on the molding of a vertically oriented wall architrave belonging to the palaestra of the South Bath-Gymnasium (*Fig. 9a*) and on the attic-ionic type column bases on the north-south oriented colonnaded street (*Fig. 9b-d*). Especially in the case of Figure 9d, it appears that the body of the column base was largely replaced with a new piece. To increase the friction, the area around the base where the appropriate piece was to be placed was first treated with a thick-tipped comb, and then, small slots were created with a plowshare to expand toward the center.
